BEAM ENCASEMENT & SFS HEAD FIXING

Technical Guidance Note - MET-TGD-01

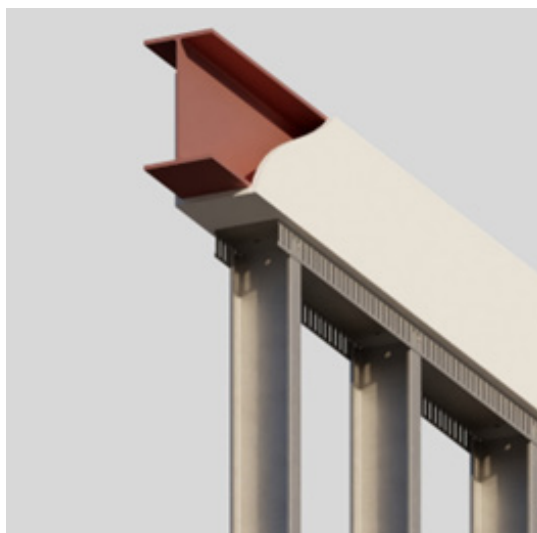
» Figure 1: Connection through encasement board

One method of providing fire resistance for a primary steel frame is to encase the steel beams and columns with a fire-resistant board. Boarding systems are tested to ensure that the hot rolled steel they encase is kept below the critical temperature to ensure sufficient strength remains. This boarding is however located at the same position as the structural connection for a secondary framing system, such as a light gauge steel SFS system. A proposed detail, which has been adopted by some SFS suppliers, involves fixing the SFS head track through this boarding and effectively sandwiching it between the head track and primary hot rolled steel (Figure 1: Connection through encasement board). While this detail is regularly used

for internal drylining walls, several unknowns exist around the long-term suitability of this detail for external walling applications, due to the higher horizontal forces exerted by an external wind load. voestalpine Metsec have maintained that a direct steel-to-steel connection is the preferred fixing method for a SFS system, due to a number of concerns around the suitability of this detail.

The primary concerns with this detail are:

- » Cyclic wind loading can lead to fatigue failure of fixings due to bending, potentially causing dislodging and falling of SFS panel and cladding. Fatigue is a sudden and catastrophic failure which can be impossible to inspect for when built into a wall.
- » Increased horizontal wind loads may cause greater head/base track movement, resulting in board compression and damage.
- » Placing a compressible board between SFS and primary steel can lead to board degradation over the structure's lifespan.
- » Damaged board may lose its original fire protection capabilities and allow excessive SFS track movement, risking finish cracking.

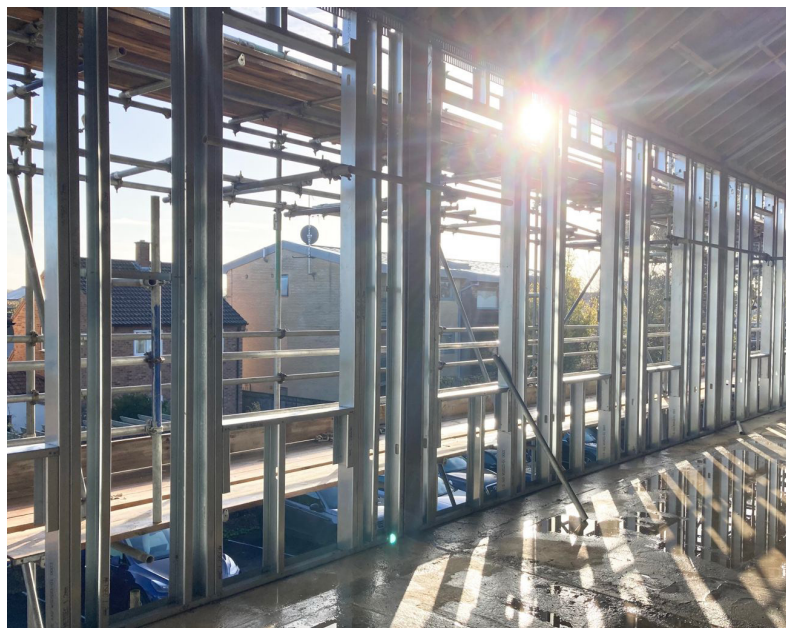
There is wide agreement within the construction industry that further testing to establish design limitations of the detail is required. Of particular concern is the risk of fatigue failure of the fixings, and the long-term durability of the encasement board. While the SCI report provides a recommended fixing capacity, thus making it possible to design the head track fixings

with a reduced capacity, this does raise questions over whether projects with this detail currently installed need to be design reviewed.

This next stage of testing will need to focus on the movement of the head track under load, and whether this could have a long-term impact on the performance of the fire protection board, rotation of the SFS head track, or lead to fatigue failure of the fixings.
